# Soil Erosion, Landslides and Hazard Mapping as well as profiling in Gandaki Province

Provincial Government  
Ministry of Forest, Environment and Soil Conservation  
**Forest Directorate, Gandaki Province**  
Bagar, Pokhara, Nepal

2021

Title:  
Study of Soil Erosion, Landslides and Hazard Mapping as well as  
profiling in Gandaki Province

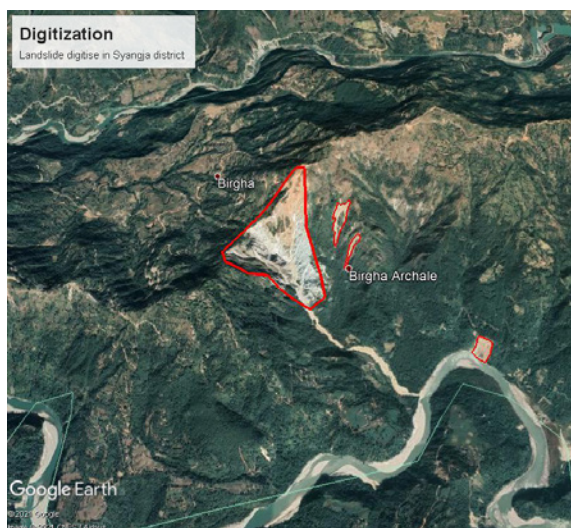
Figure 25 Landslide from Birgha Archal, Syangja digitised in Google earth (Left), recent False Image for January 2021(Right)
